Pittsburgh, Pa.
October 3 and 4, 1980

Guidebook for the
45th ANNUAL FIELD CONFERENCE OF PENNSYLVANIA GEOLOGISTS

LAND USE AND ABUSE
THE ALLEGHENY COUNTY PROBLEM

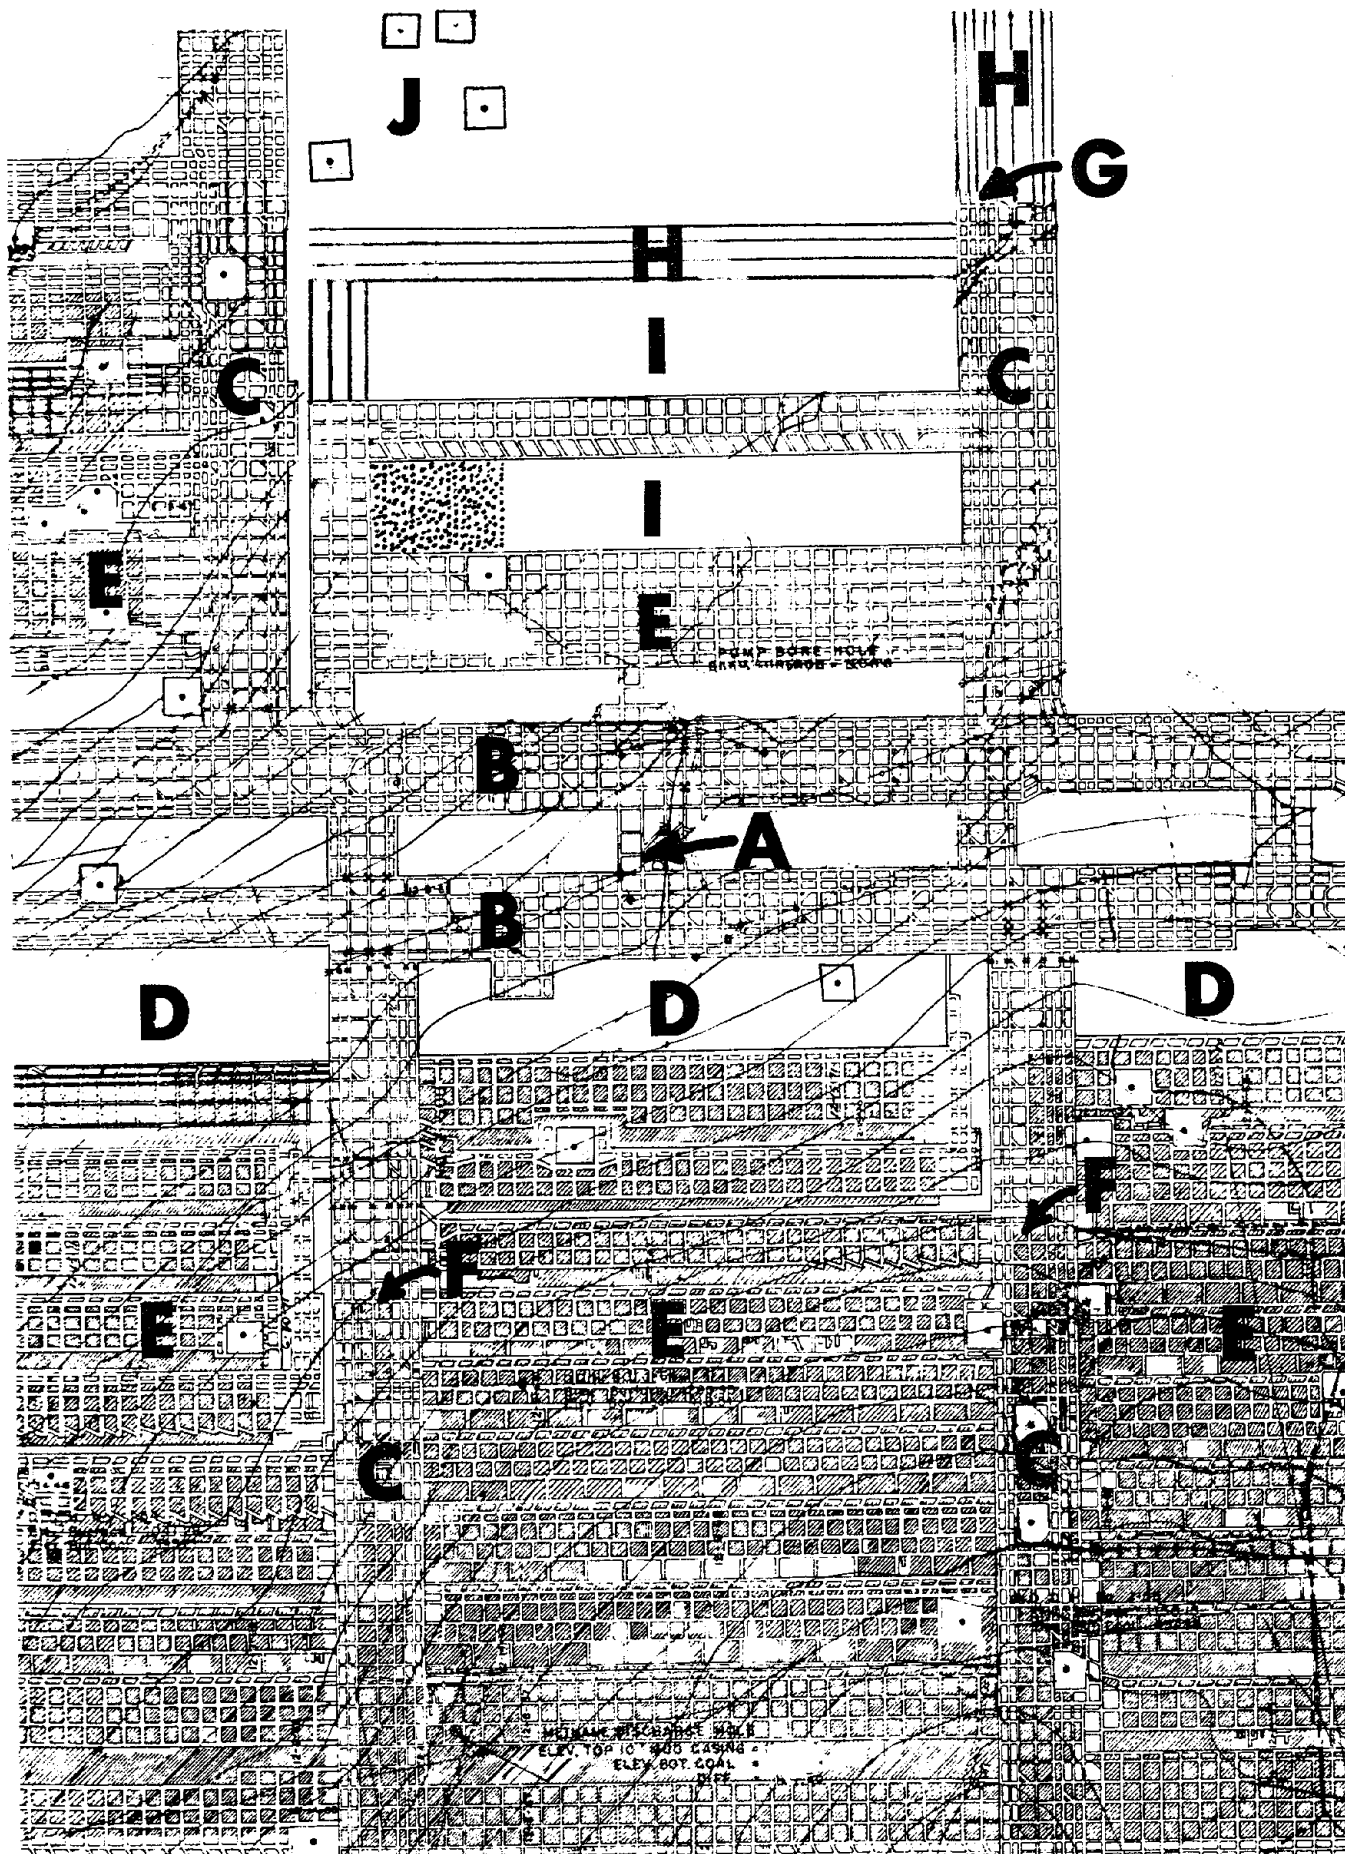
Figure 7. Map of part of a large underground coal mine. Contours indicate seam elevation in 5-foot intervals; the structure is an anticline. Scale: 1 inch = 2,000 feet.

A. Shaft. Ventilation of this mine is through a shaft.

E. Room-and-Pillar Panels. Panels about 1000 feet x 6000 feet have been developed individually by driving entries and crosscuts, then retreat mined by removing pillars. Shaded pillars have been mined while unshaded pillars have been left because of adverse mining conditions.

J. Gas Wells. Coal within 150 feet of unplugged gas wells may not be mined because of the danger of gas leaking into the mine. In a 5-foot-thick coal seam about 5000 tons of coal must be left for each well. There are 28 wells in this part of the mine, an unusually large number.

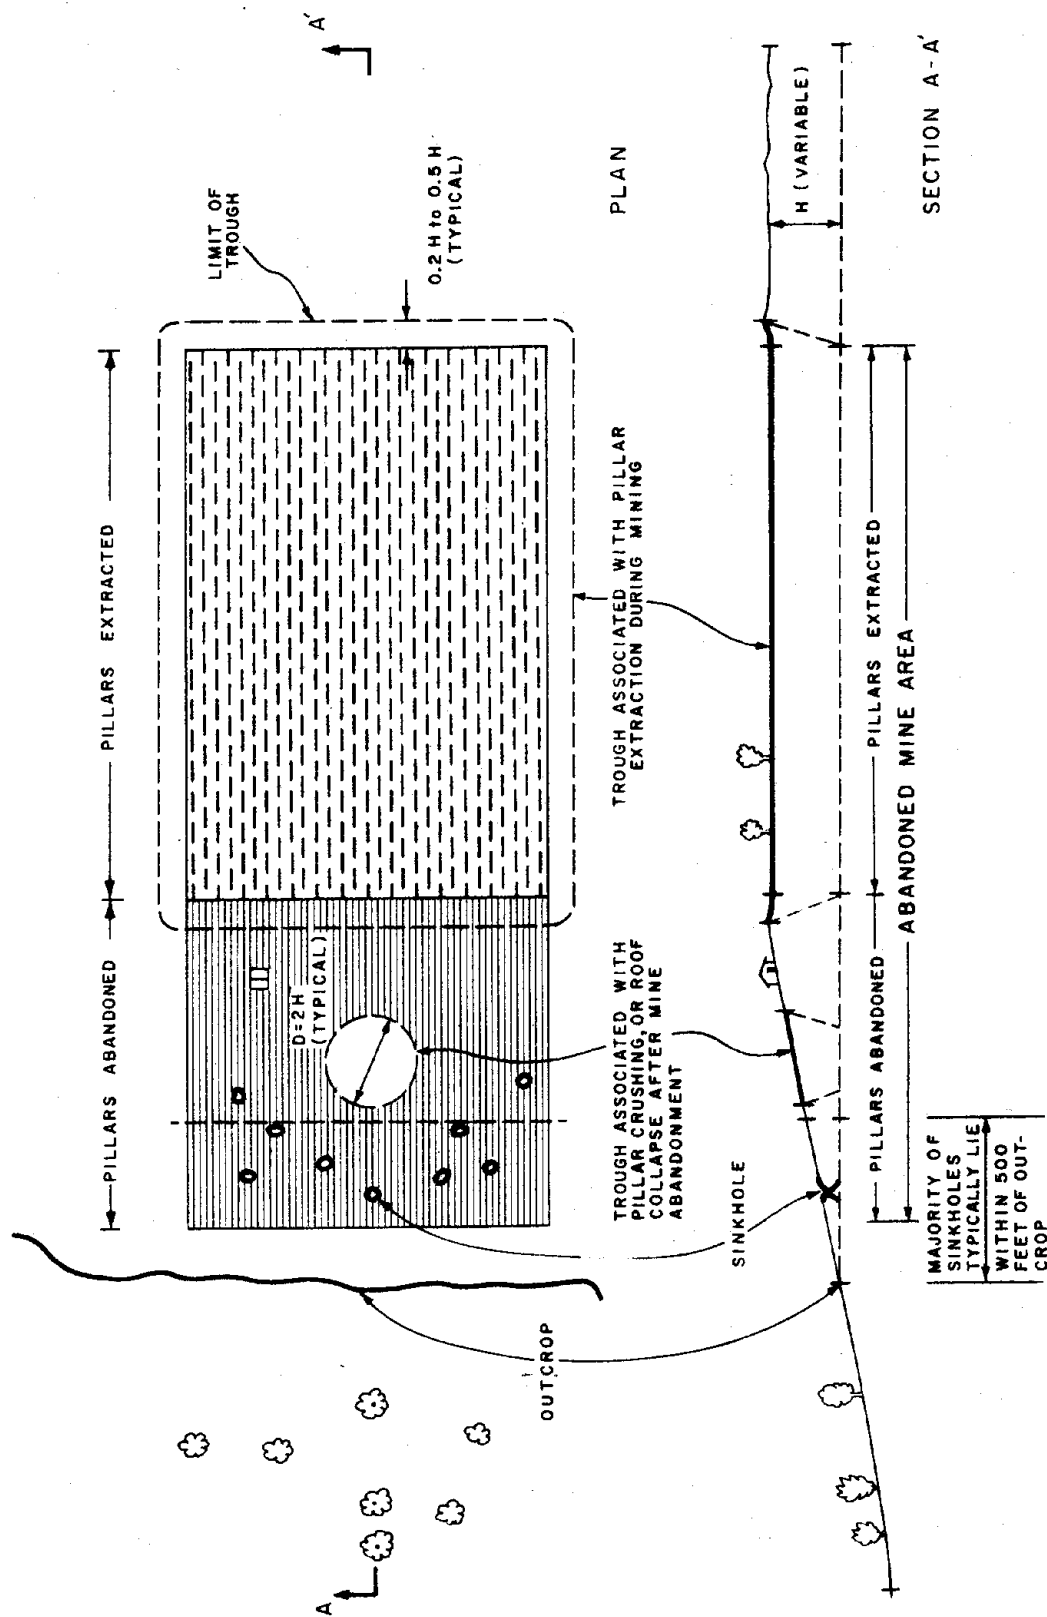
Figure 10. Typical modes of mine subsidence in western Pennsylvania

gorized as either sinkholes or troughs (Figure 10).

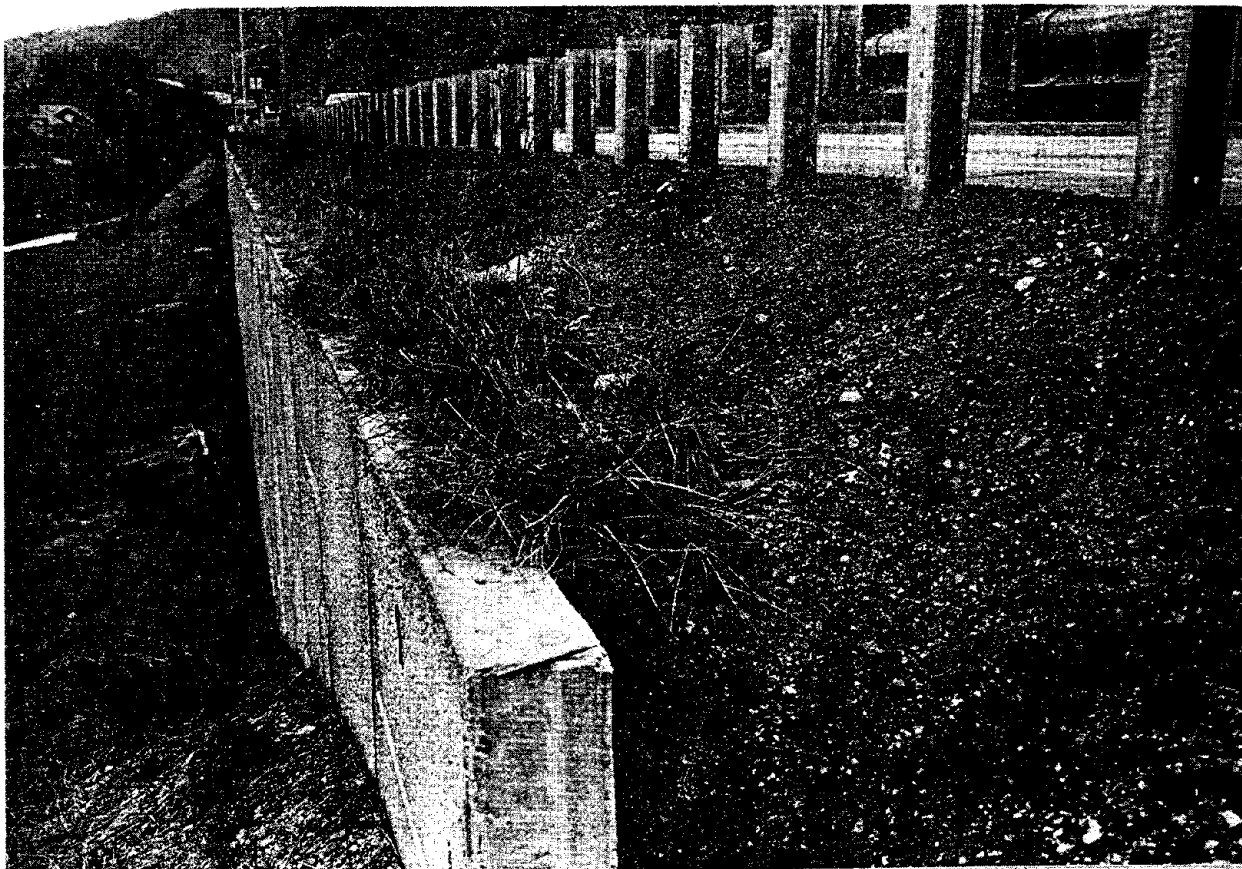
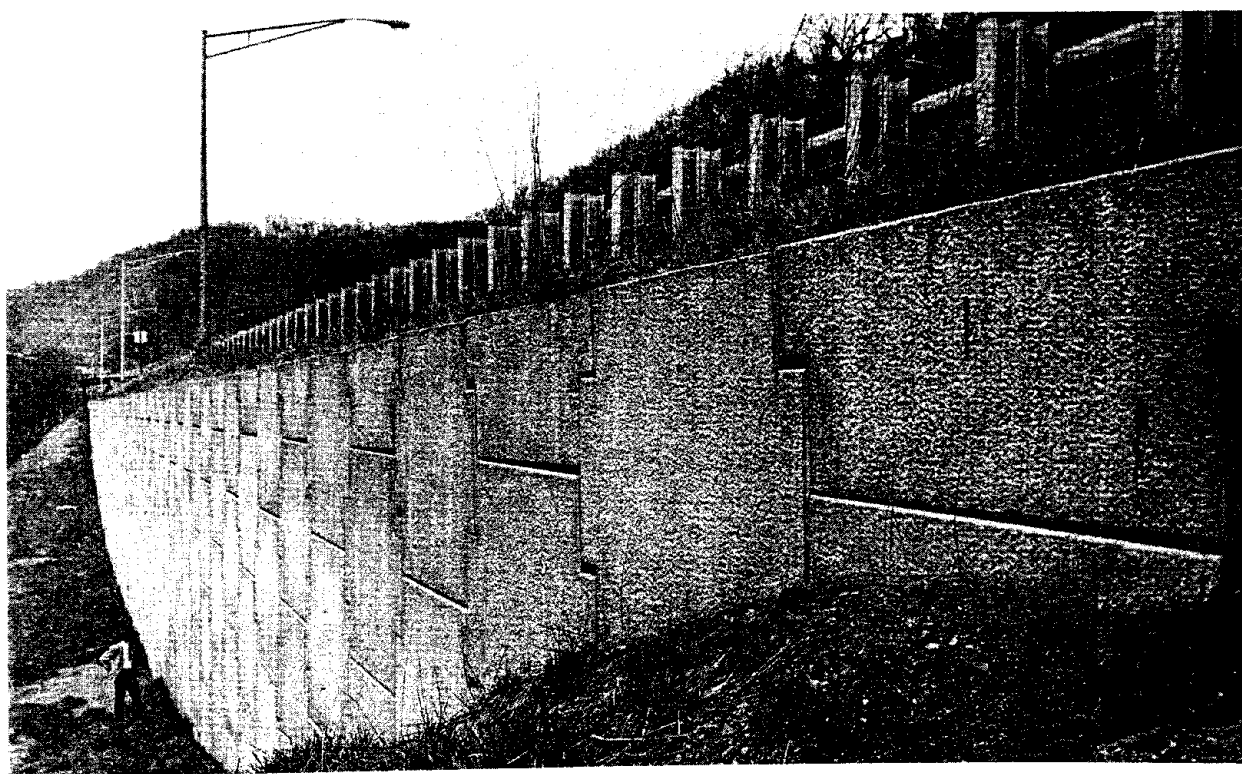
Figure 14. Two views of the reinforced earth wall at landslide site on Allegheny Valley Expressway (Route 28) at Aspinwall, looking west.

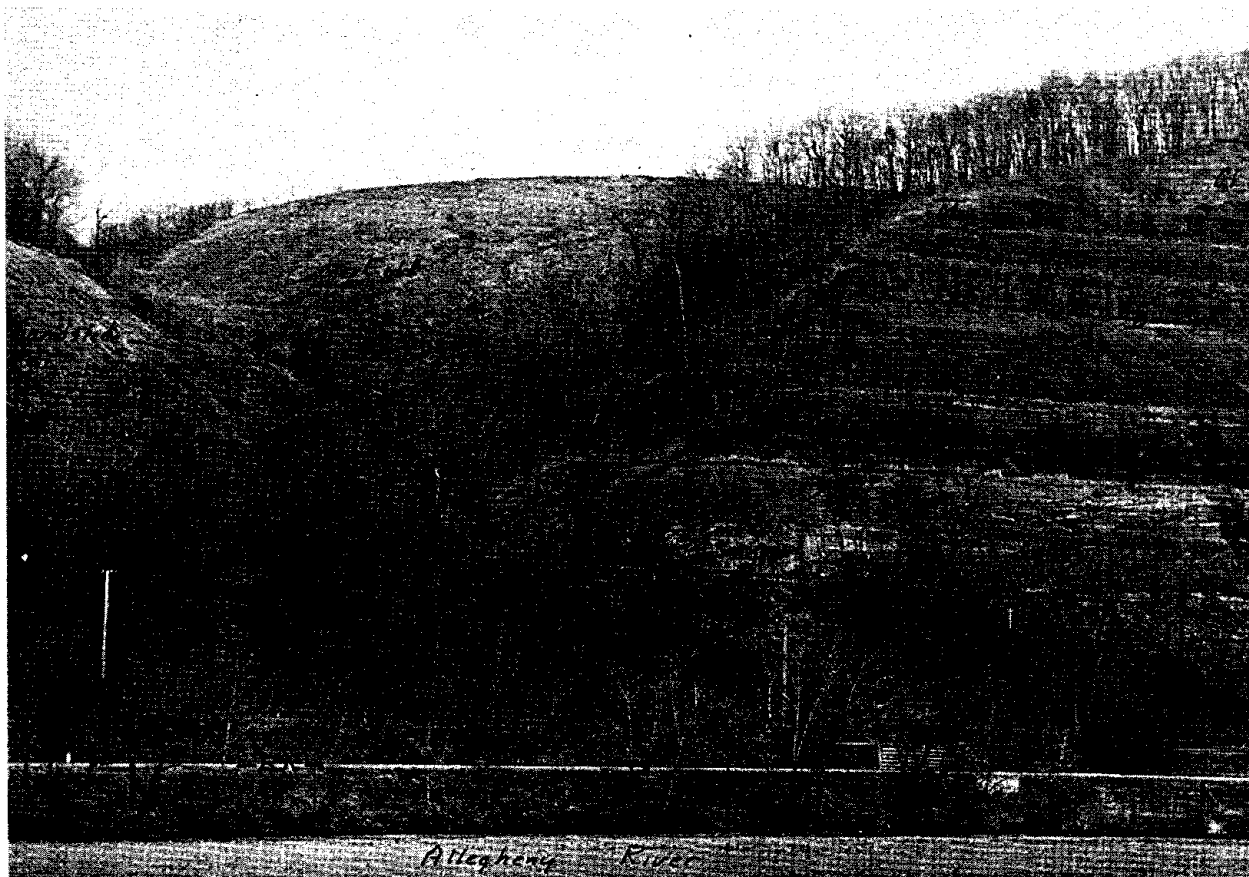
Figure 15. Roadcut on Route 28 in the Conemaugh Group, 0.4 mile north of Powers Run Road.

| C1 - Clarksburg redbeds | Ba - Bakerstown coal |

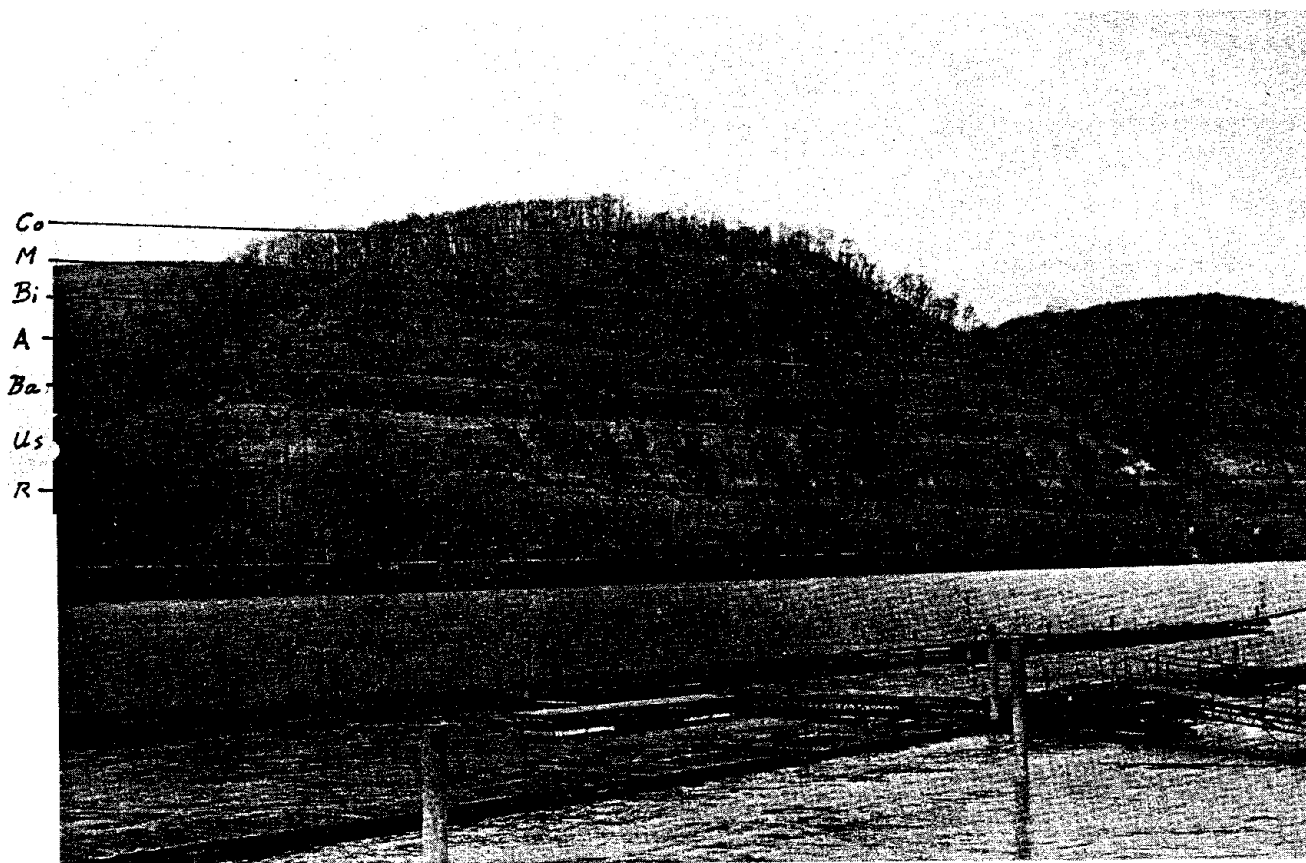
Figure 16. View at north end of the Route 28 roadcut at Hulton Bridge.

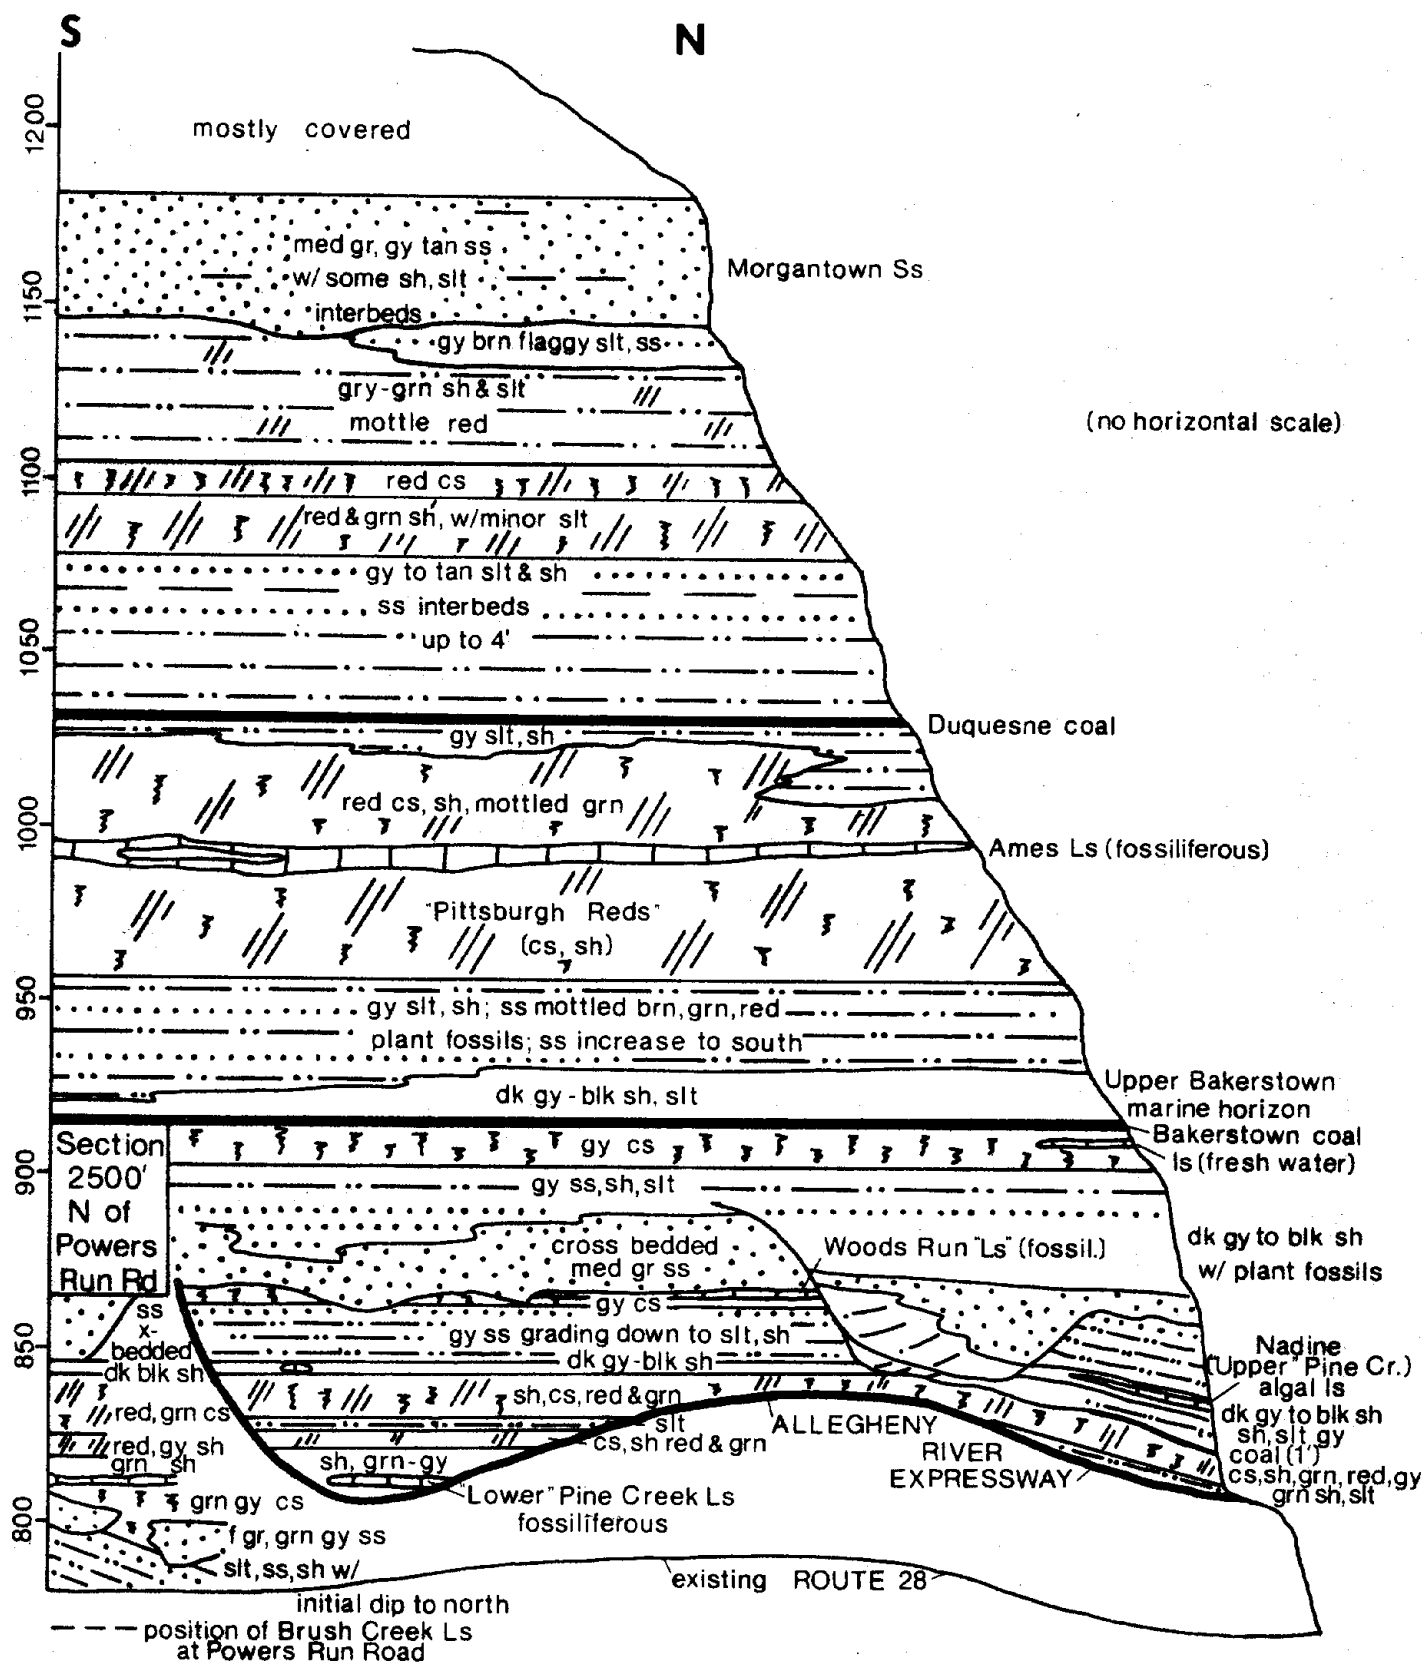
Figure 17. Sketch of the stratigraphy of the outcrop at Hulton Bridge along the Allegheny River Expressway (after D. R. Kelley, W. R. Wagner, R. Lund, 4/71).

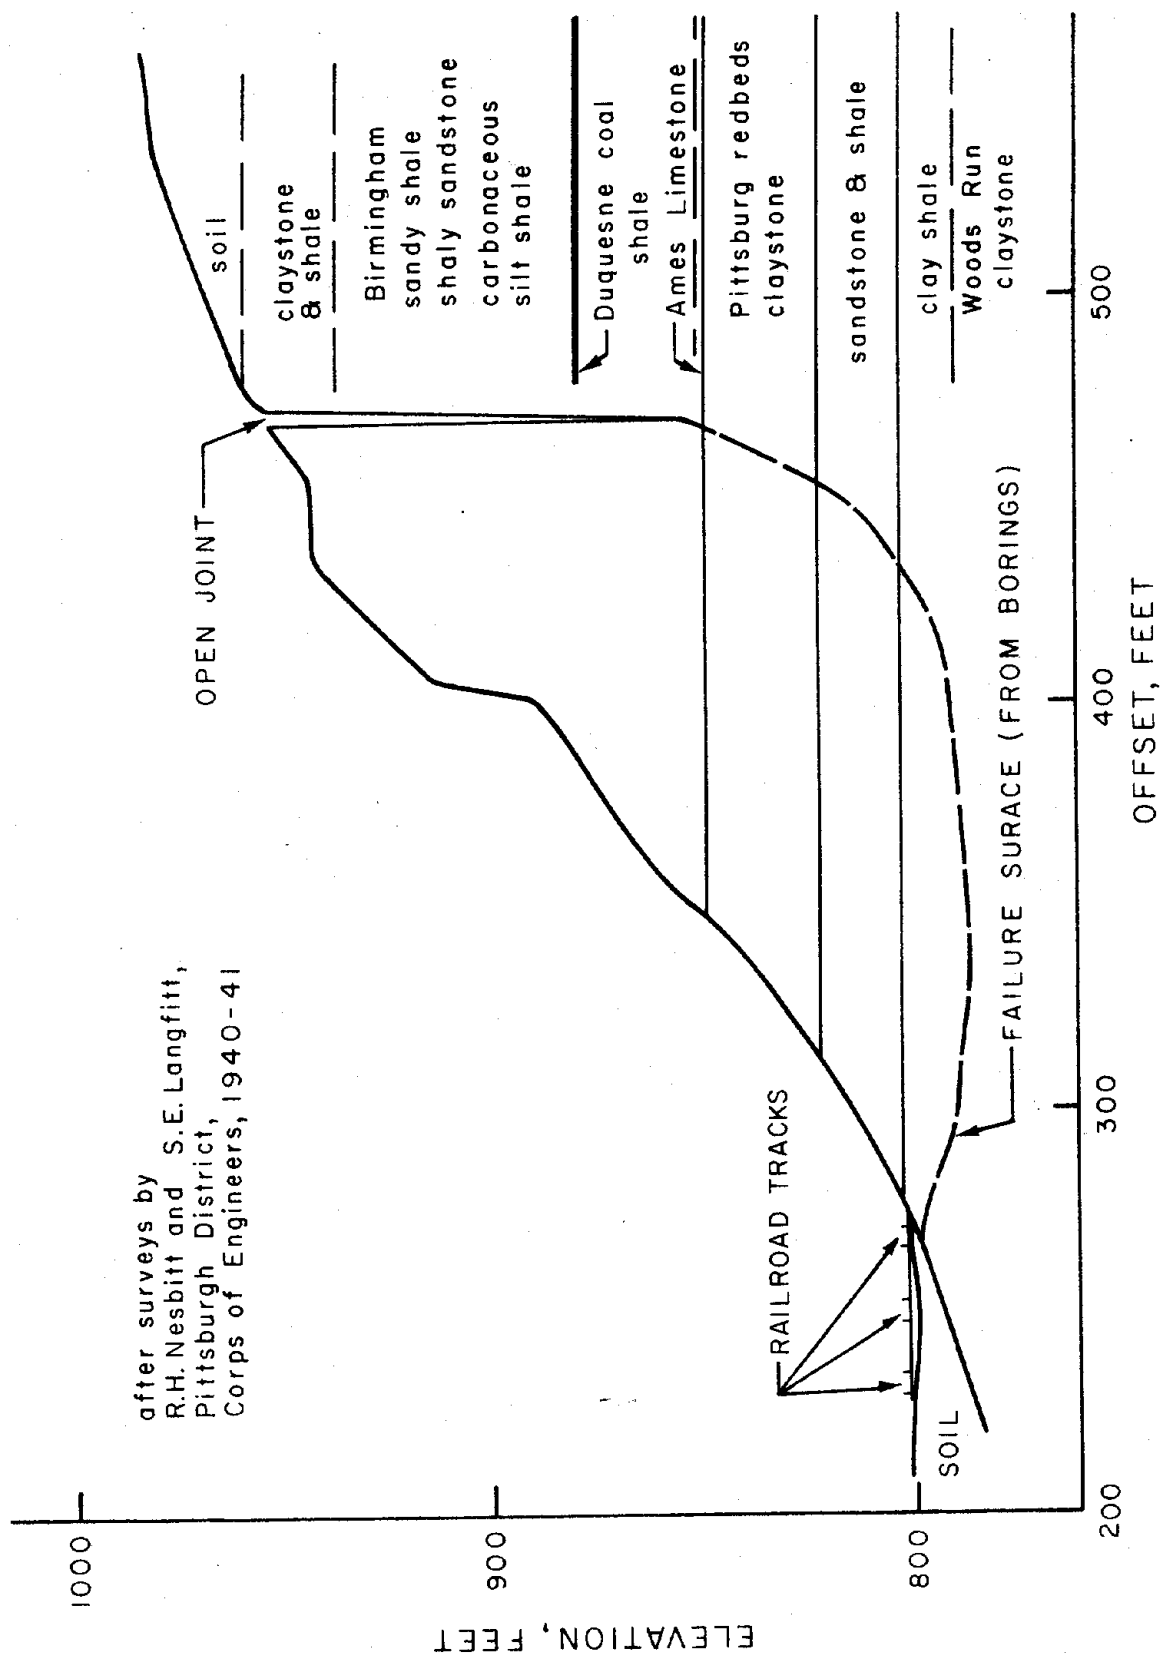
Figure 18. Generalized cross-section, Brilliant Cut (modified from Hamel, 1972, and Gray, Ferguson, and Hamel, 1979).

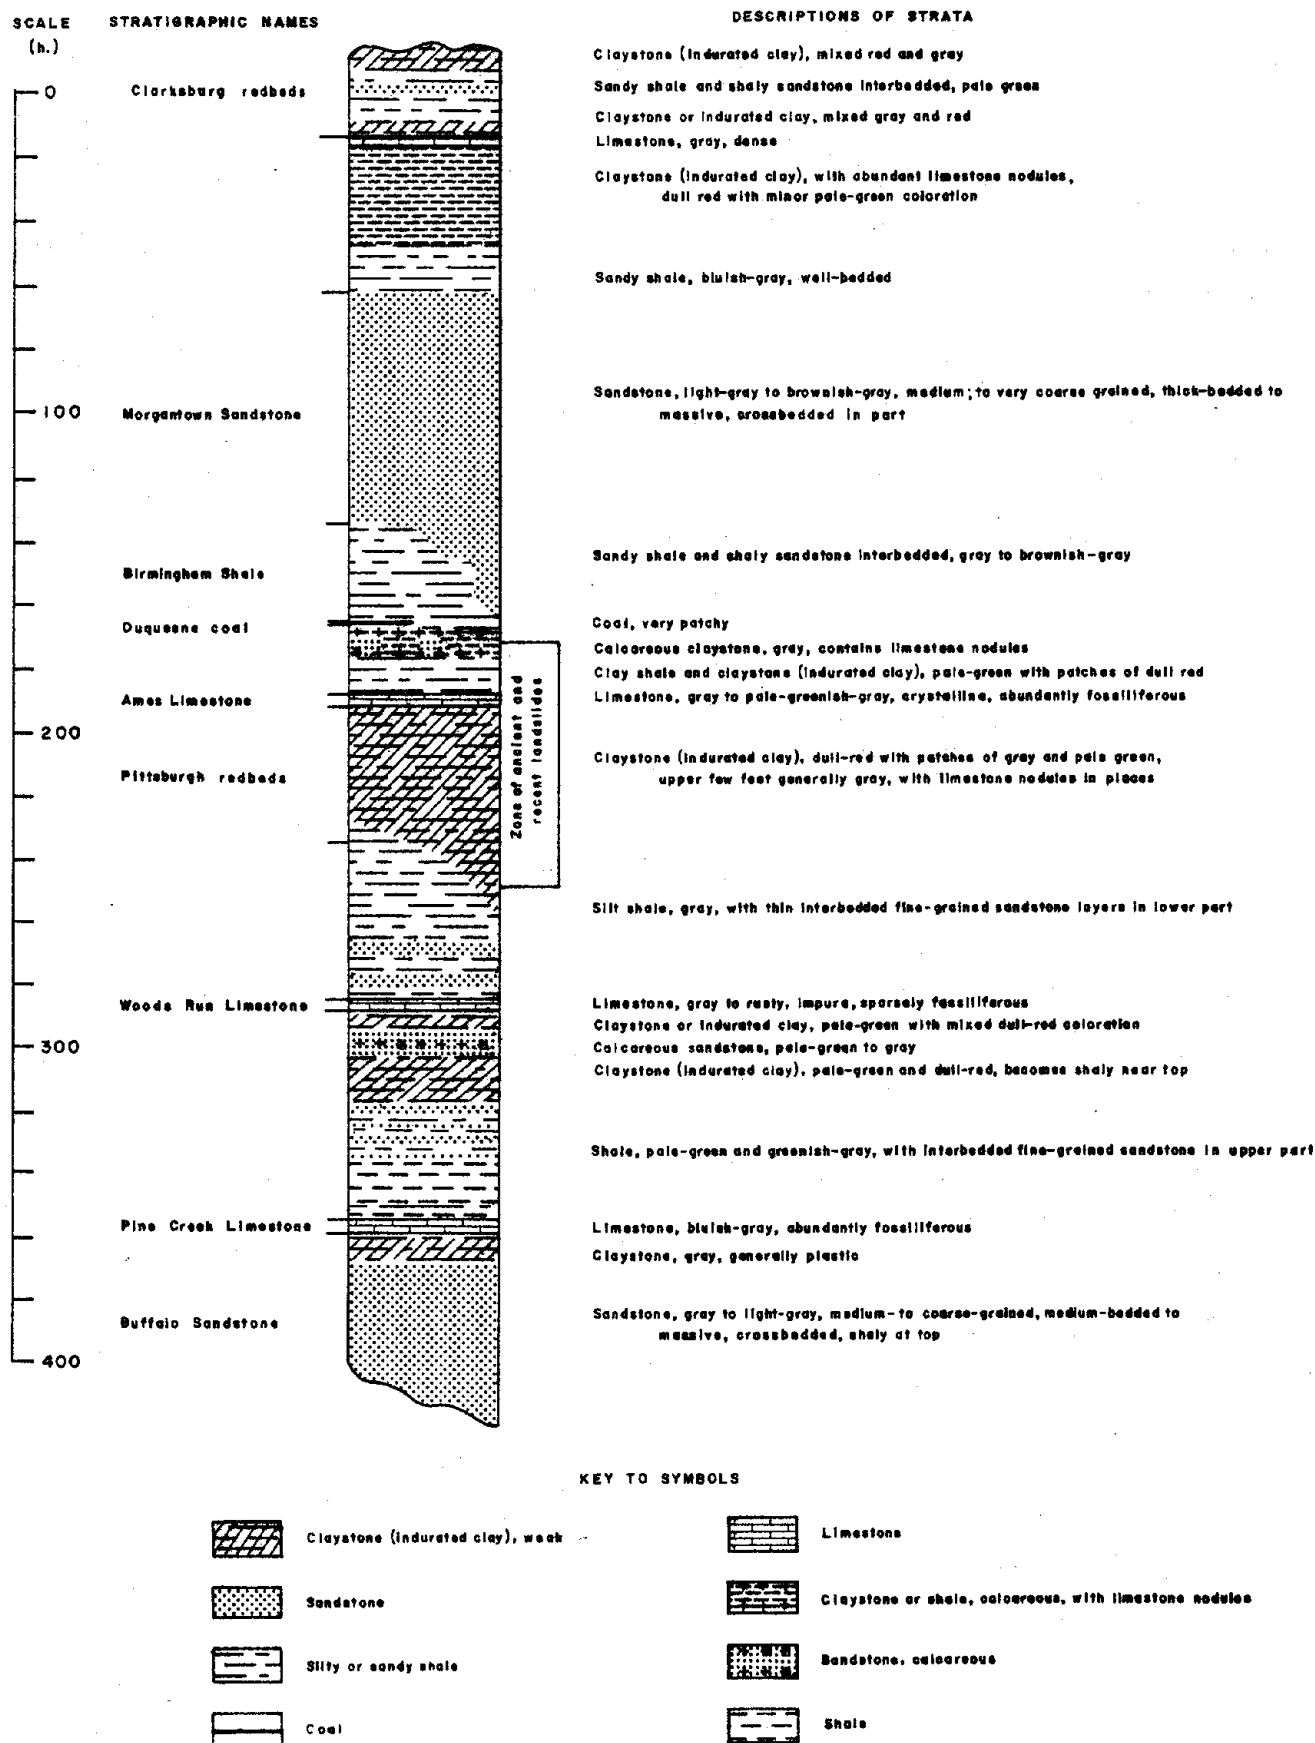
Figure 22. Stratigraphic section of the Glenfield area (modified from Hamel and Flint, 1969).

At this site we see where extensive landsliding occurred because of undercutting of older landslide masses at the stratigraphic level of the weak Pittsburgh redbeds. Later, at STOP 4, we see a proposed highway construction site (I-279) with potential for landsliding in essentially the same geologic setting. See index map (Figure 21) for location of STOPS 3 and 4, and see Figure 22 for stratigraphic section of Glenfield area.

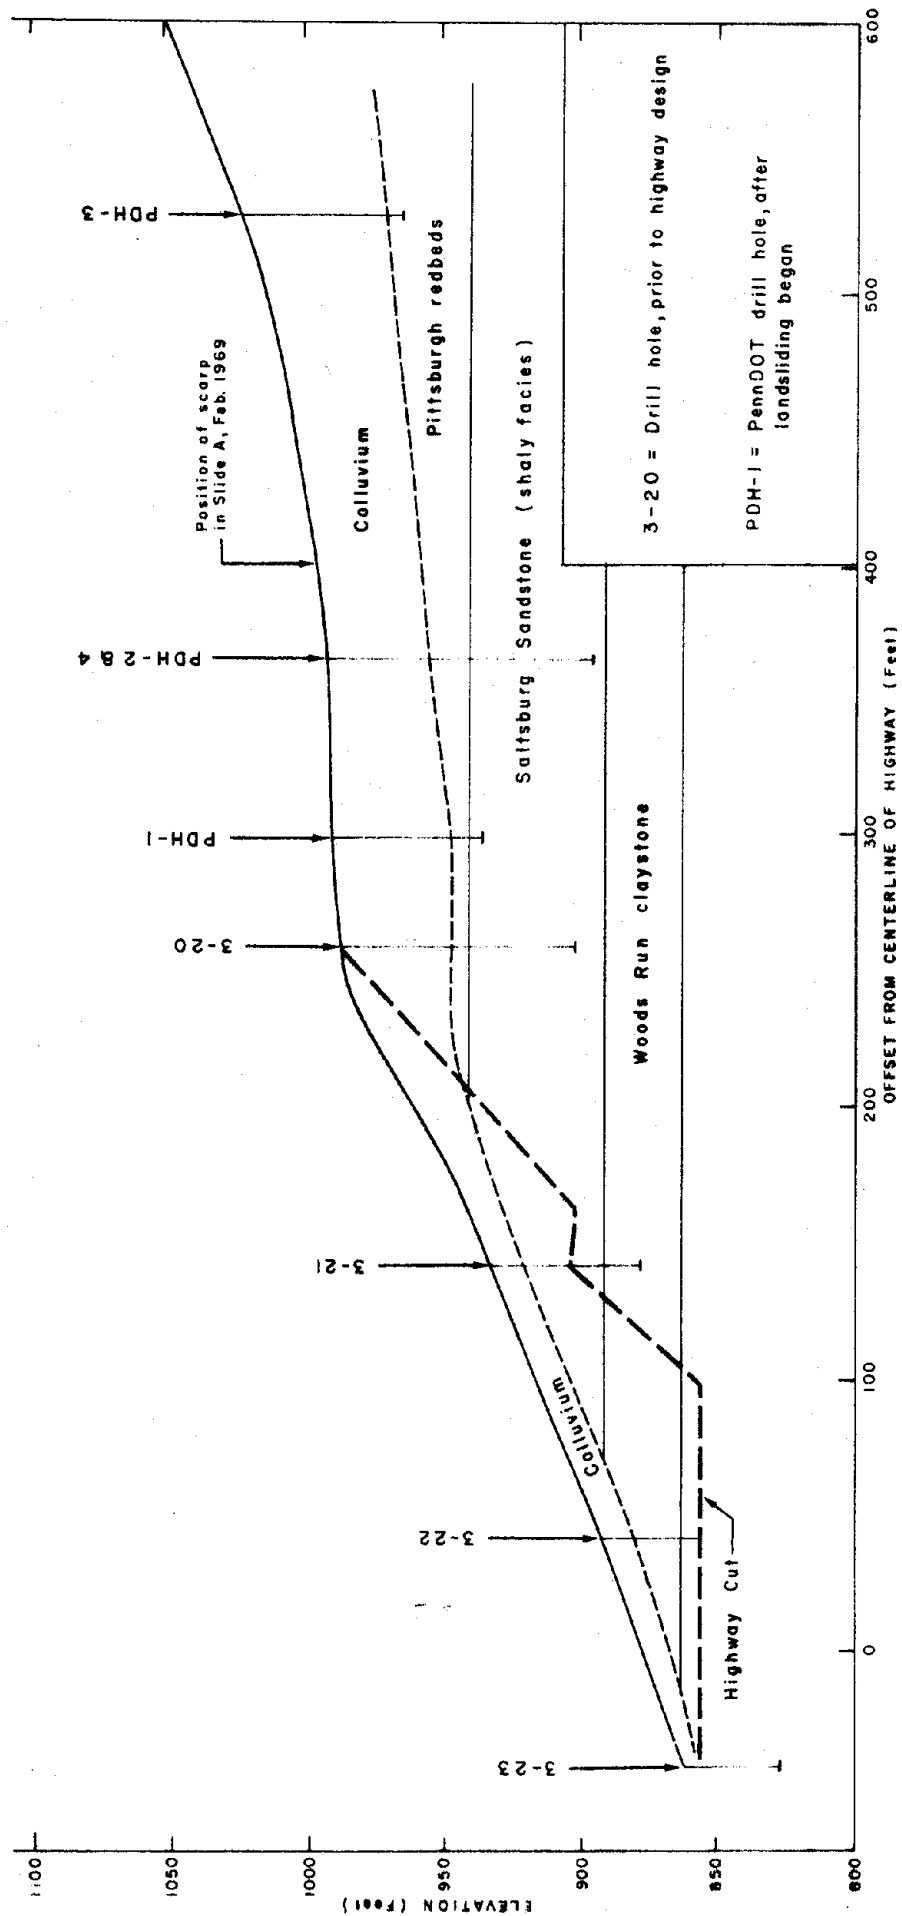
Figure 24. Geologic cross section at Station 908+00, Slide A, I-79, Glenfield area.

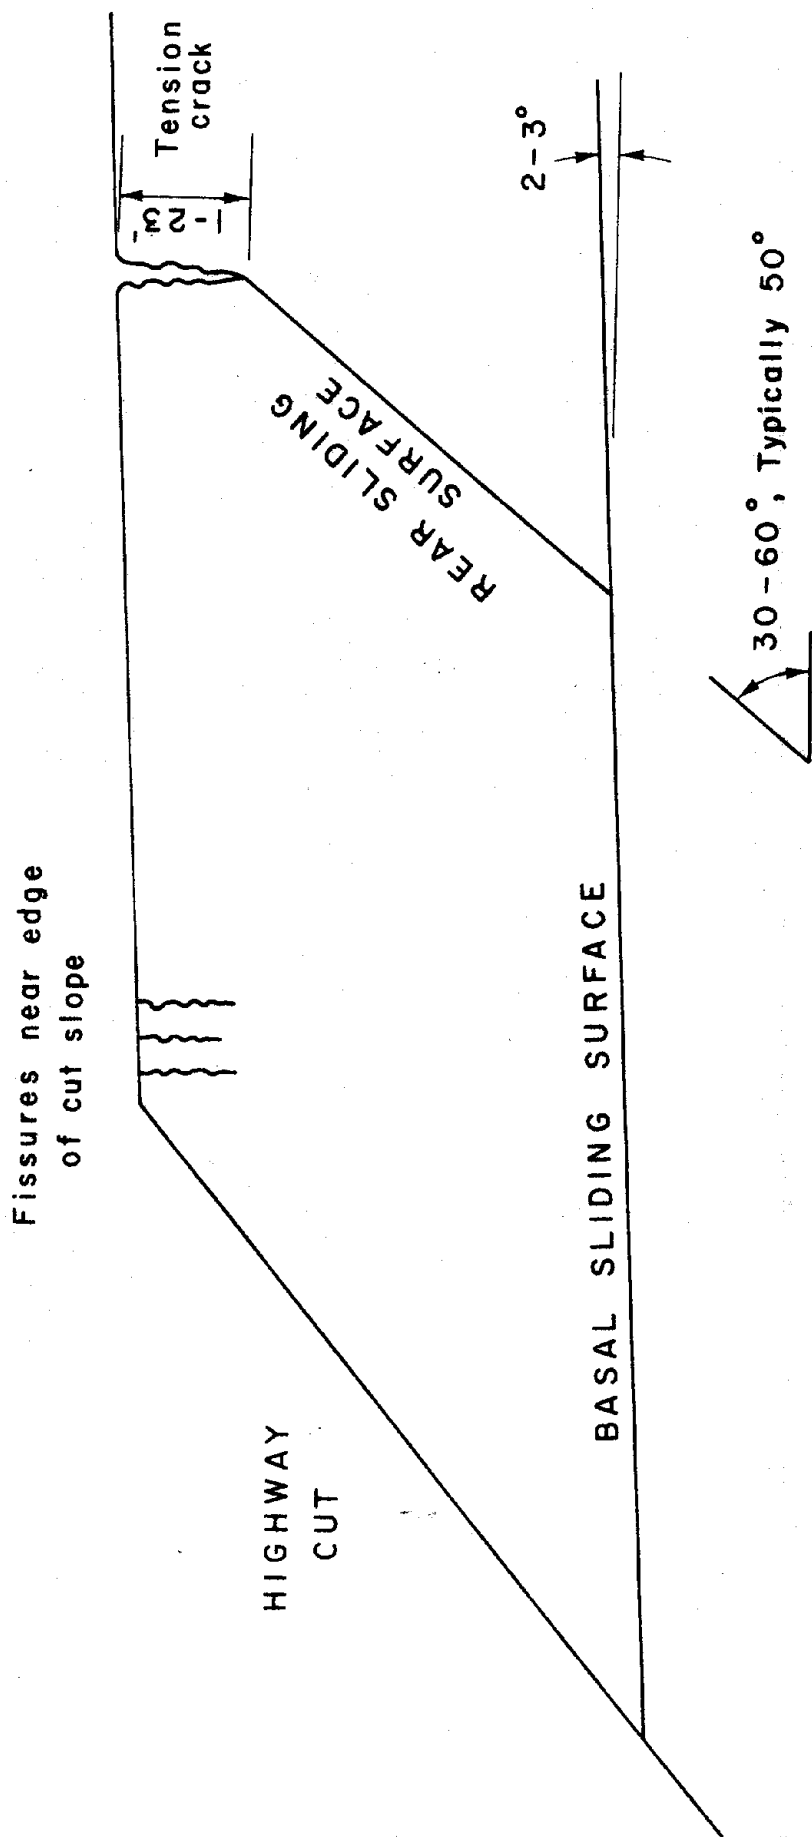
Figure 25. Schematic cross section of typical failure mass, I-79, Glenfield area.

Another factor in the landsliding was groundwater in a perched zone above the clay of the shear zone. Surface water that permeates through the Morgantown Sandstone appears at the surface as spring water, then slowly infiltrates the colluvium on the slope below, and develops a perched water zone there. Increased pore pressure resulting from this water buildup is a factor that promotes landsliding. Valley stress relief from the downcutting of the valley itself was also probably influential in causing the Glenfield slides. After the field stop, reboard the buses and proceed on I-79 northward.

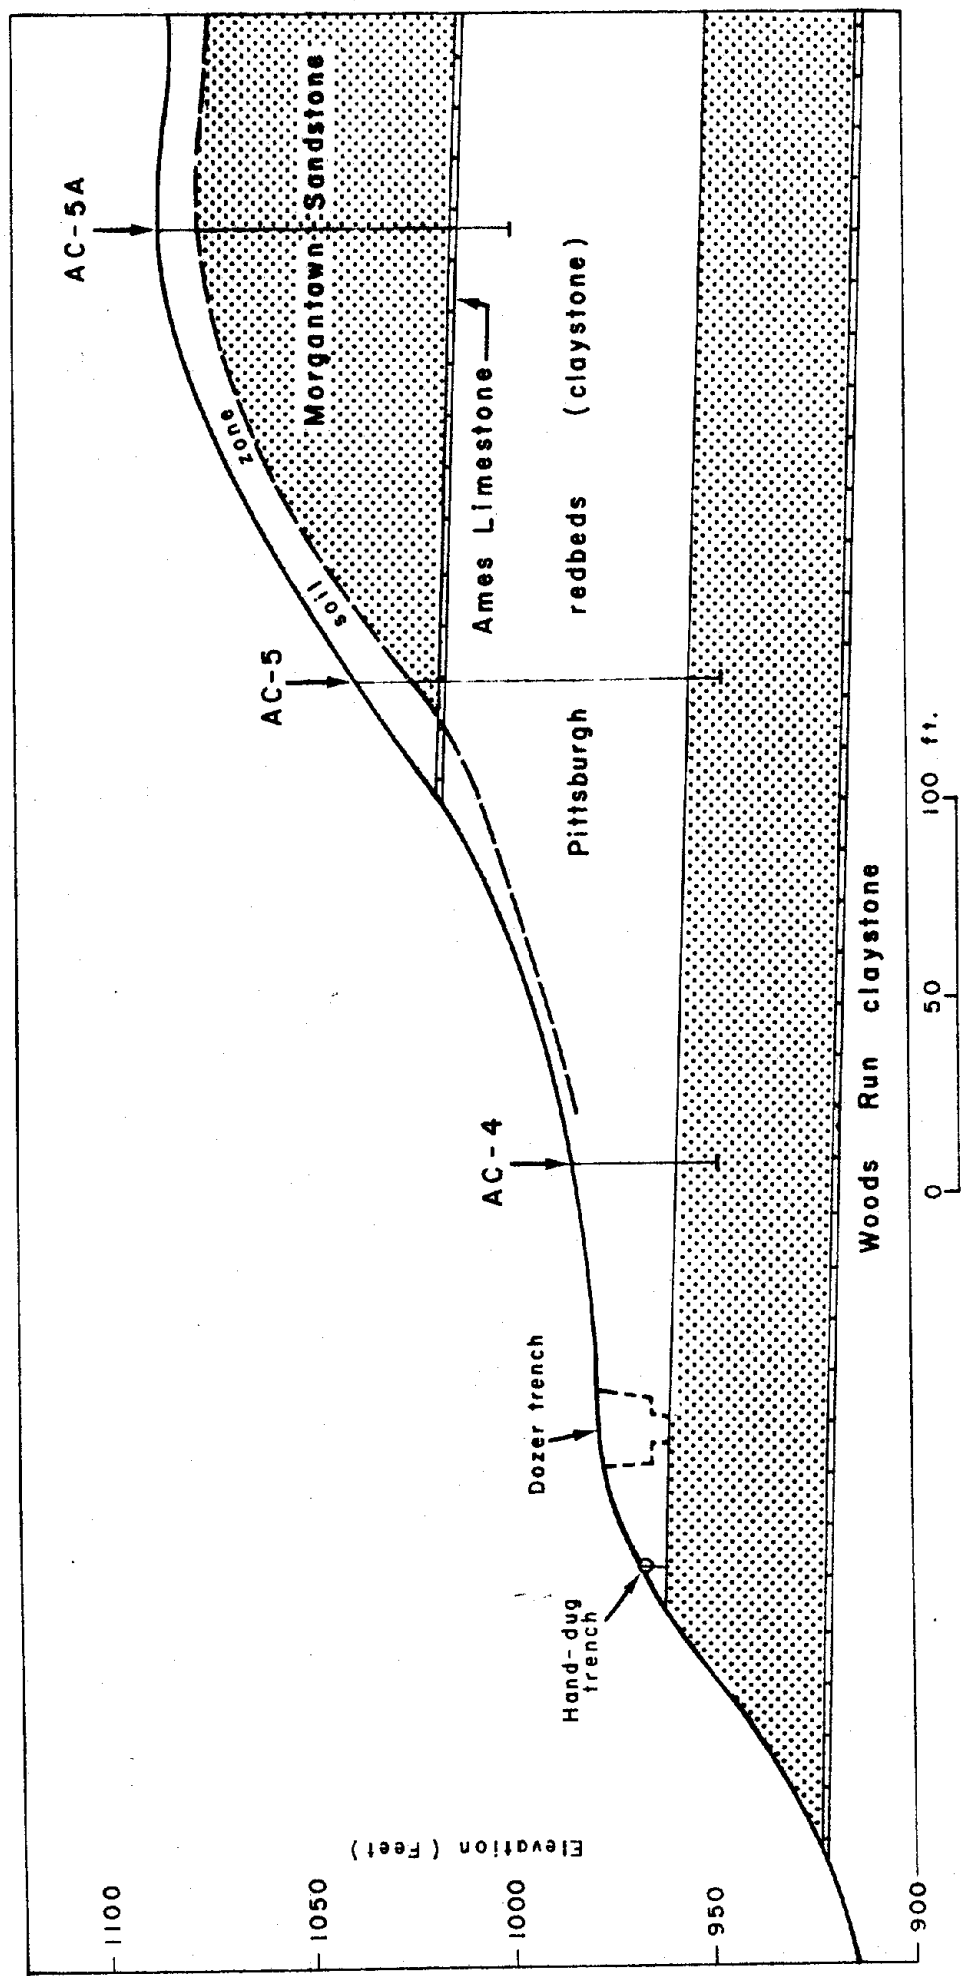
Figure 27. Geologic cross section at Station 341+65, I-279 site.

Boring AC-5 was located in what was thought to be the main scarp of an ancient landslide. However, due to the uncertainty in the location of the Ames Limestone, Boring AC-5A was added. The rocks encountered at this location consisted of sandstone to elevation 1054, and silty shale between elevations 1054 and 1025. An unnamed unit of claystone underlies this shale to elevation 1013. At the expected location of the Ames Limestone (elevation 1013) a rather thick layer of limestone (6.5 feet thick) was encountered in Boring AC-5A, followed by a 5.5-foot layer of silty shale. As stated earlier, the Ames is generally two to three feet in thickness and underlain by the well known Pittsburgh redbeds. Probably the abnormally thick Ames reported here includes some calcareous shale. The Pittsburgh redbeds have a thickness of about 57 feet, and their base elevation is 955.5. They overlie a silty shale unit.

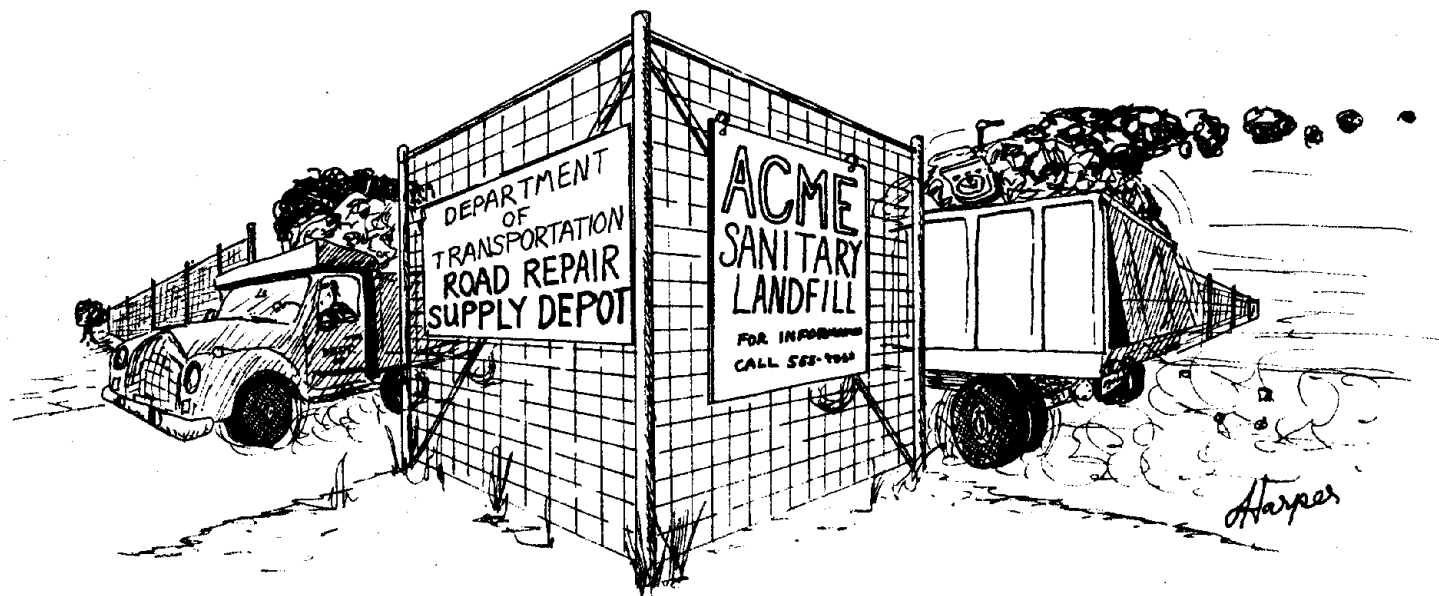
The start of this operation was in 1964. Currently the site includes 4,500 leased acres, chiefly abandoned "orphan" strip mines in the Pittsburgh coal. By early 1980 about 400 acres had been reclaimed by disposal ("storage") of municipal and, to a minor degree, industrial wastes at the average rate of 5,000 cubic yards per day, 5 days per week.

On site, relatively impermeable clay is placed over outcropping coal and adjacent rocks. Wastes are distributed in 8-to 10-foot lifts and compacted. The lifts are covered by a minimum of 2 feet of earth and at the close of each day's operations. Groundwater quality is monitored in several observation wells. Ultimately the reclaimed ground will have potential recreational, agricultural, or light industrial capability.
