**60TH ANNUAL FIELD CONFERENCE
OF PENNSYLVANIA GEOLOGISTS**

**Applied Geology
in the
Lock Haven and Williamsport Region,
Clinton, Lycoming, and Tioga Counties,
Northcentral Pennsylvania**

**APPLIED GEOLOGY IN THE
LOCK HAVEN AND WILLIAMSPORT REGION,
CLINTON AND LYCOMING COUNTIES,
NORTHCENTRAL PENNSYLVANIA**

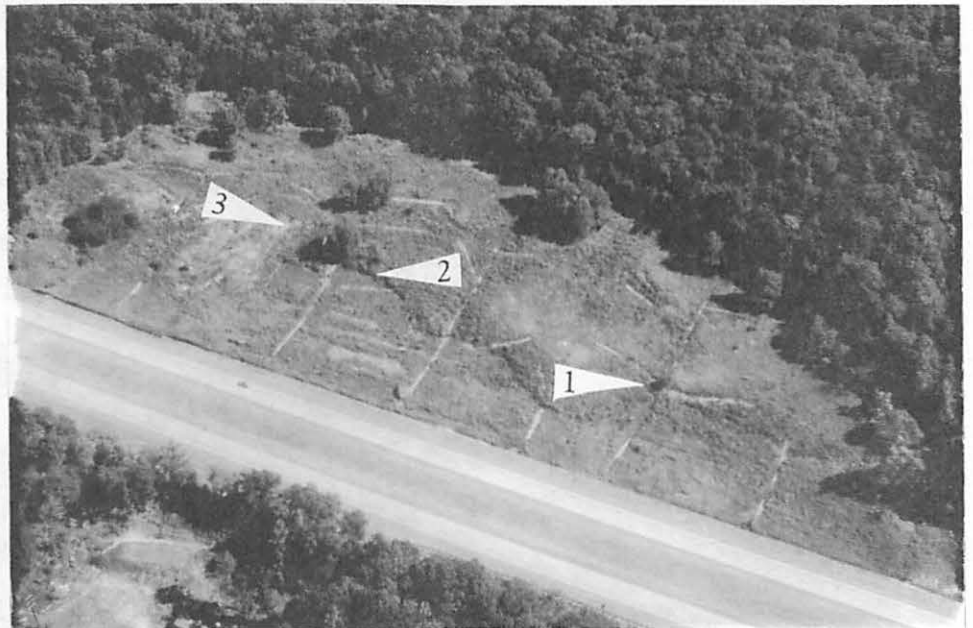
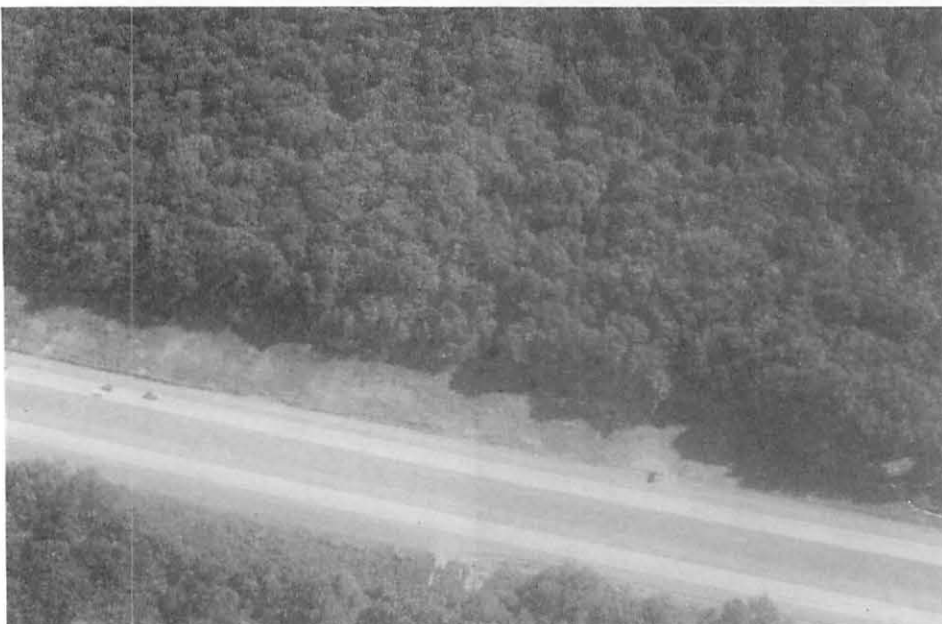
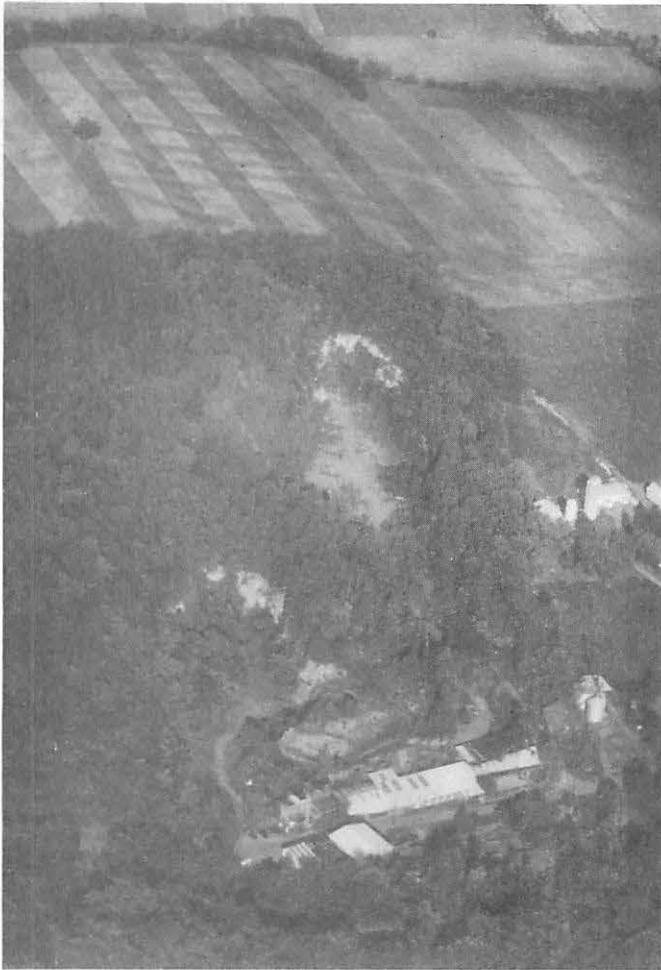
PLATE V STOP 5. US Route 220 Slope-Stability Problems

- A. View looking southwest toward one of the areas on the northwest-facing slope of Bald Eagle Mountain that has experienced extensive downslope movement of surficial materials as a result of the construction of US Route 220.
- B. Somewhat closer view of the same area as in A (above). Note: (1) the "Y"-surface drains, (2) the edge of a mass of moving debris, and (3) unvegetated patches corresponding to portions of the slope that have undergone relatively recent movement.
- C. View along another nearby stretch of US Route 220 experienced a similar fate.
